ROYAL COMMISSION
QUEBEC BRIDGE INQUIRY
1907

VOL. II.

MINUTES OF PROCEEDINGS

PRINTED EXHIBITS

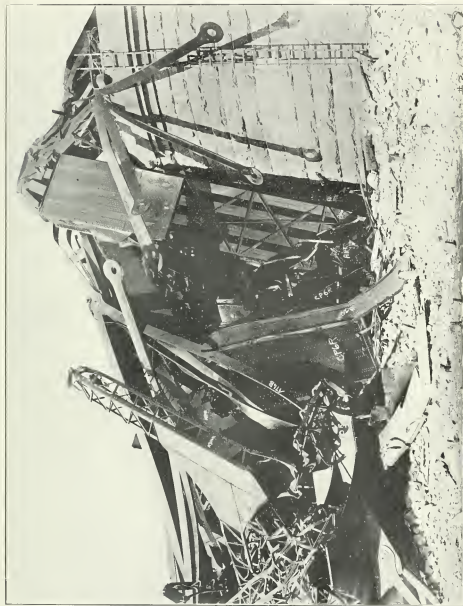
1. View showing the centre post cap, finials, diagonal T5 and the upper chords in panels 9 and 10 Anchor Arm. The centre post has been practically bent double over the main pier by the drag of the cantilever arm. Note that the end of the pier is clear of wreckage.

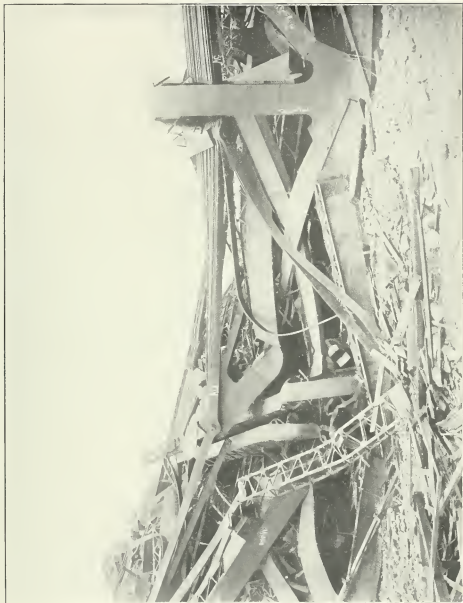
12. View from the west showing the beginning of the first 180° bend in chord A9L.

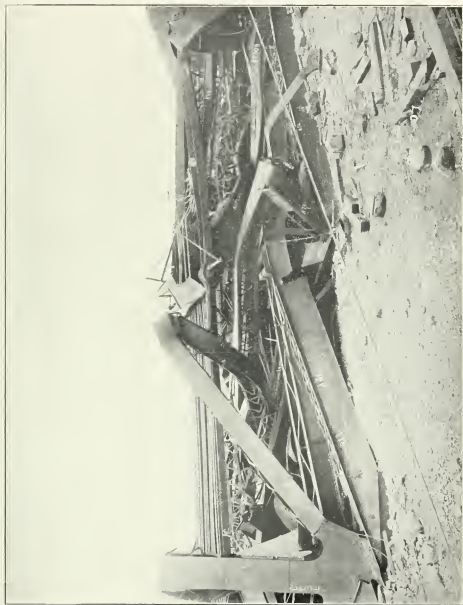
13. View showing the foot of post P3L. Note the distortion of this post and the effect of the foundation holes on the lower chord.

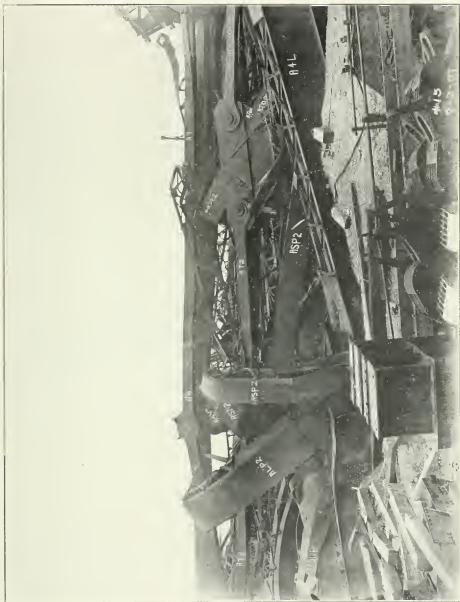
14. View showing the foot and hanger A7000L and the top of post AUP2L. Note that the outer movement of the upper chord with reference to the lower chord is almost exactly one panel length.

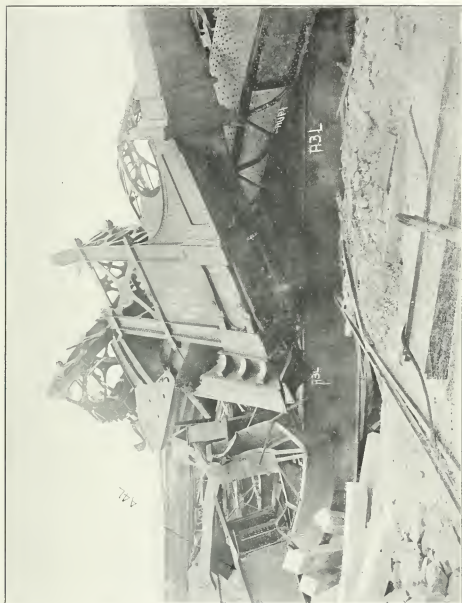
15. View showing the foot of post P2L. Note how the ribs of ASP2 cut the cover plate of A4L at some stage of the fall; the counter block in the foreground; and the condition of the link connecting AT2 and AT20.

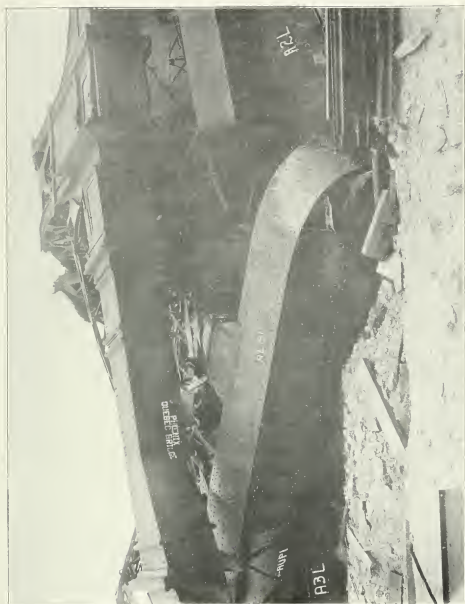
16 View showing the wreck of the portal. Note the fracture of the splice plates between A3L and A4L.

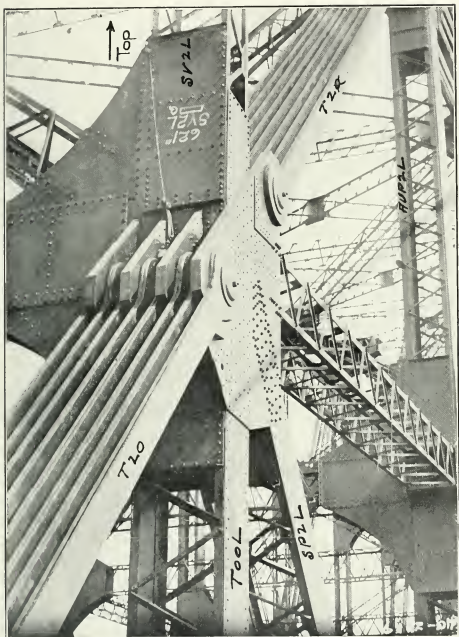
14. View of bottom chord intersection between panels 8 and 9, cantilever arm, west truss. The lower chords on the opposite truss (8-R and 9-R) are duplicates of those shown and were failing on August 27.

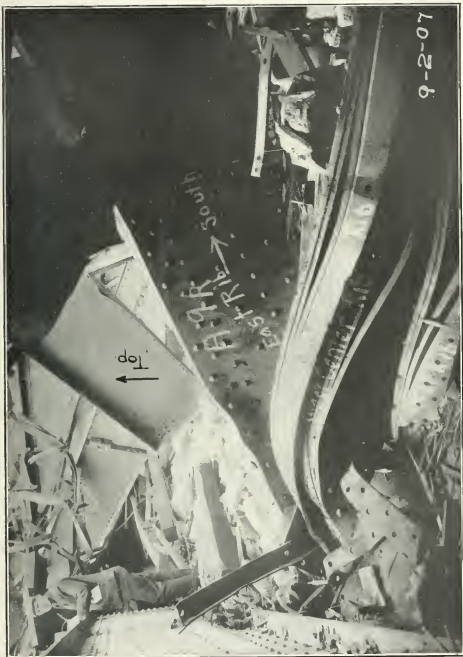
18. View of the shop splice between panels 9 and 10, left truss anchor arm. Note the bend in chord A 9 L. Date, Sept. 2, 1947.

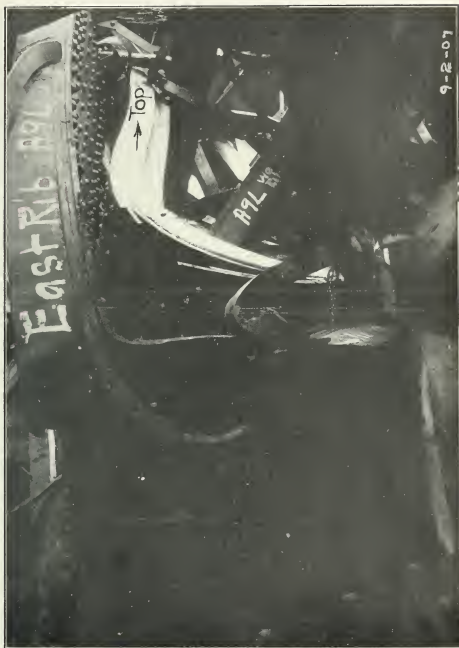
19. View of the wreckage of chord 9, right truss anchor arm. Note the bend of the ribs which is nearly 180 degrees near the lattice bar in the foreground, and the chord has been turned upside down. The lower chord in the left of the photograph is A-7-R. Date, September 2, 1907.

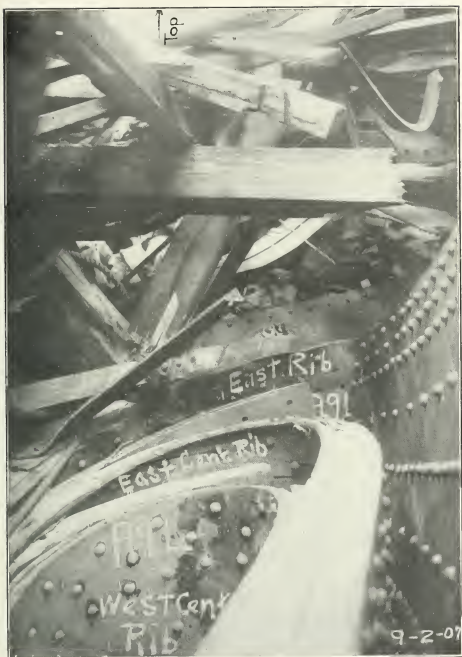
20. View of inner bend of chord 9, left truss anchor arm. The view is taken looking south and all four ribs are visible, the angle of the bend being roughly 90°. Date, Sept. 2, 1907.

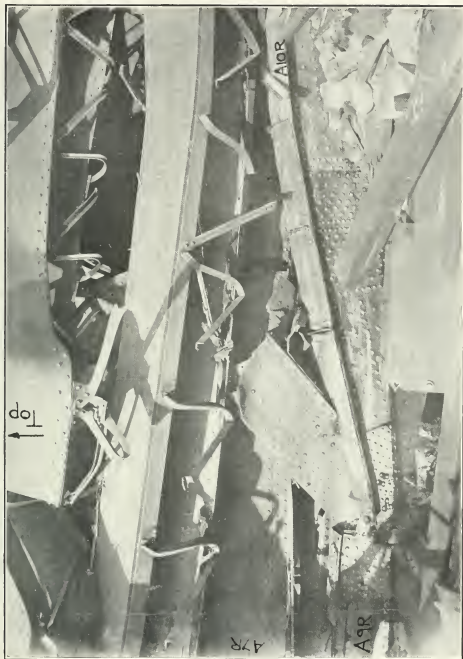
21. View of bend shown in 20, but taken looking north. Date, Sept. 2, 1907.

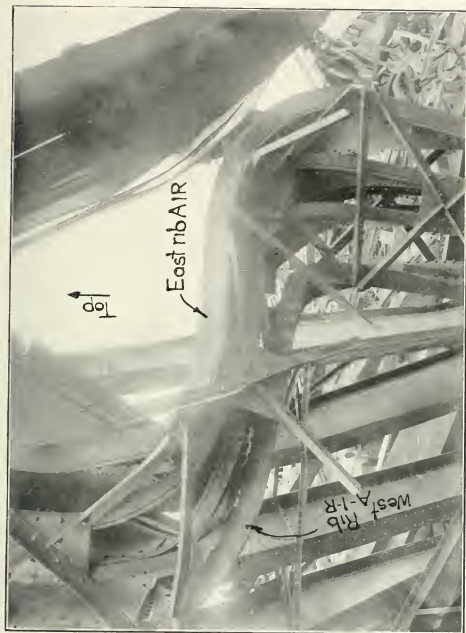
22. View showing the ship and field splices between clords 9 and 10 right truss, anchor arm. Note on the left that clord 9 passes under clord 7.

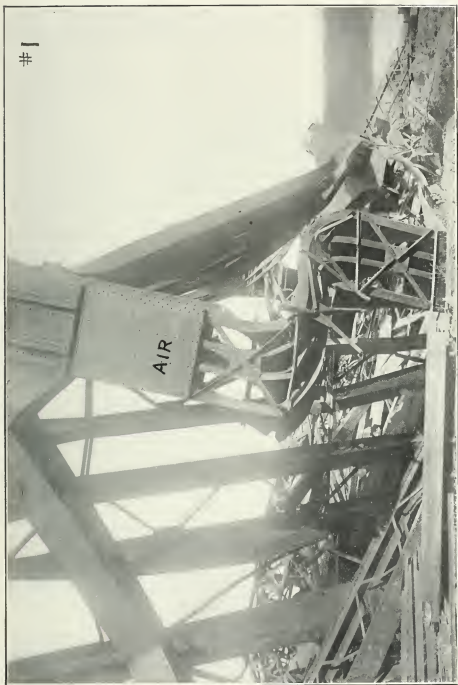
1

1. Show, buckling of chord AIR between cover plates; also efficiency of covers and diaphragms in keeping members straight. The offset from the edge of the upper cover plate in the photograph to the corresponding edge of the lower cover plate is 7' 11", and the offset between the two plates at right angles to the plane of the picture is 9' 6". The chord apparently struck the ground end on and the buckling shown resulted.

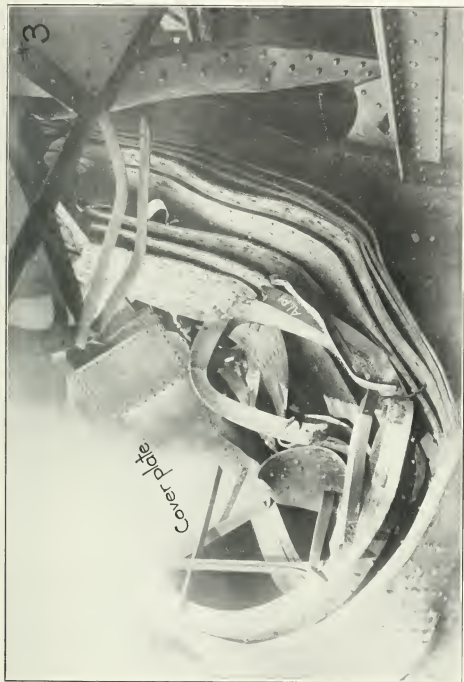
3 Shows detail of distortion of post ALP1. Note the gradual parting of the laminated webs, the distortion of the lattice angles and also the straight lines retained by cover plates.

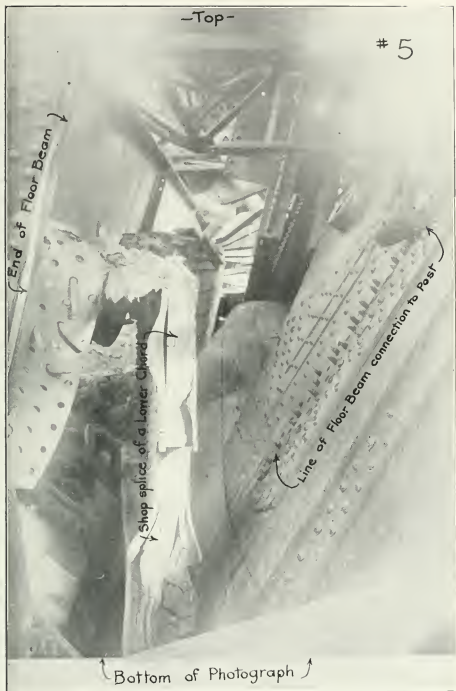
5. Shows typical rupture of connection of floor beam to post. This action is undoubtedly the result of the fall. Note the general uniform strength of the joint as indicated by the failure in various ways of the floor beam connection angles, and also of the rivets. In this instance, where the rivets failed they yielded by direct tension, and almost without exception necked down in the same manner as a perfect tension specimen pulled in the laboratory.

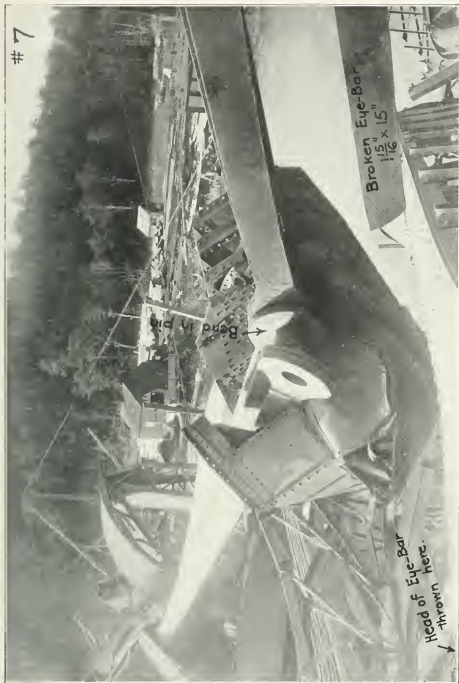
#7

7. Shows the one bent pin in the debris, being the pin between top chord members A₁L and A₂L. This photograph also shows the only broken eye bar, which will be observed resting on a built-up member at the lower right hand side of the picture. The head of the bar was thrown about 15 feet to the left. There is every evidence that the blow which caused the damage to the webs of the post below the pin also bent the pin and broke the eye-bar.

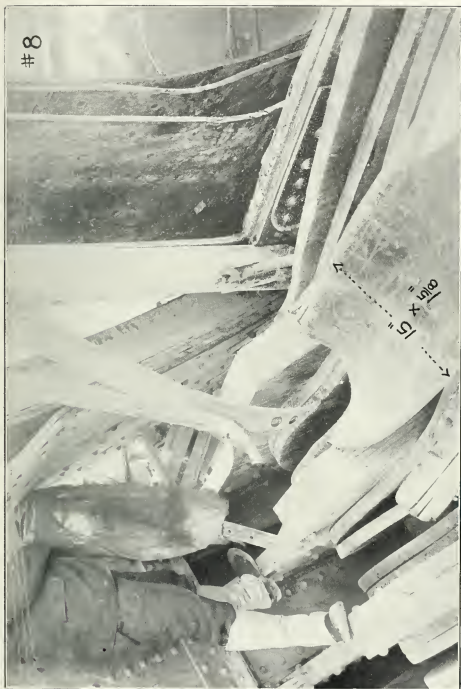
8. Shows a remarkable test of the quality of steel in the eye-bars. This bar was one of a set of main diagonals, and its body was $1\frac{1}{2}'' \times 1\frac{1}{2}''$. The forces set up by the fall twisted the body of the bar through an angle of 90 degrees in a distance of about 2½ feet while the head of the bar still remains in its original position on the pin. There is no evidence of any failure of the bar on the accessible surfaces.

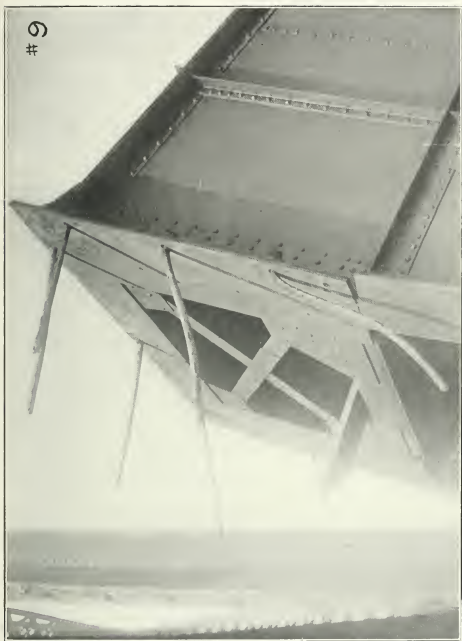
9. Shows $1\frac{1}{2}$ inch anchor bolts which hold the foot of each shell surrounding the eye-bar anchor rods at the top of the anchor pier. These bolts were ordinary steel rods, 4 feet 6 inches long, and swedged every three inches on opposite sides. The holes in which they were set were drilled in the granite. The bolts were supposed to have been grouted in with pure Portland cement. In every case where they received direct tension they pulled bodily out of the masonry.

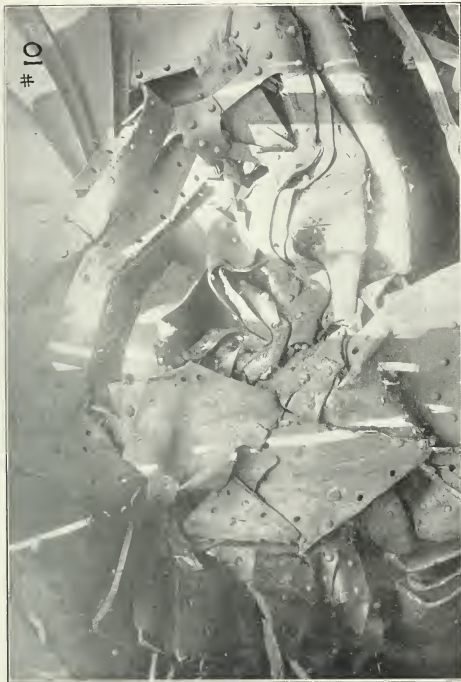
10. Shows the complete chaos to be seen at some points of the wreckage. This view is interesting only as an indication of the magnitude of the forces at work during the catastrophe. Even in this distorted mass there is no evidence of poor material.

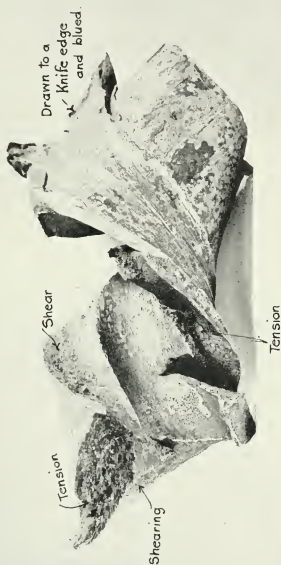
17. Shows a fragment of $\frac{1}{8}$ " plate originally about 2" x 6". This specimen is unique, showing clearly its quality by having been bent spirally as if a three-eighths rod had been used for a core about which to bend it. It also exhibits a beautiful fracture from shearing. It has a perfectly fibrous fracture from failure in tension. Its ductility is proven by a terrific sliding force which indented and scored it throughout its whole length and finally drew it to a knife edge. This action set up so much heat that the specimen is perfectly blued at this last named point. This specimen is photographed to exact size.
